Case Report

A Novel Technique for the Removal of an Intramedullary Femoral Guidewire Lodged in the Femoral Canal

Spartan Medical Research Journal

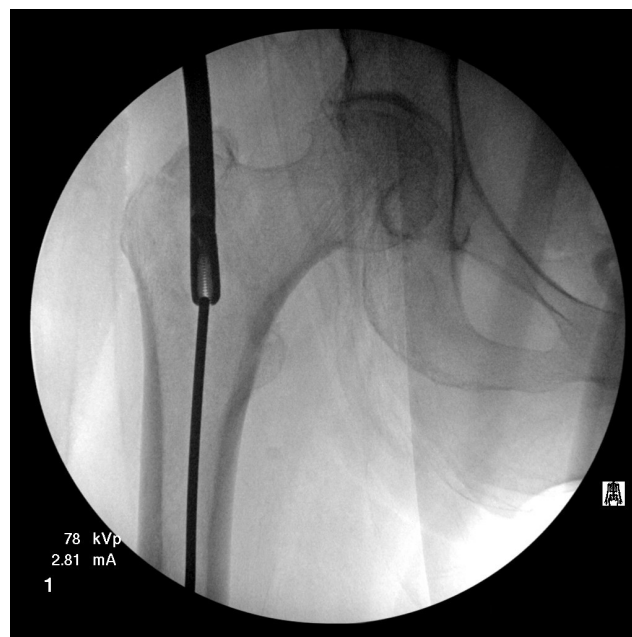
Multiple failed attempts were made to remove the guidewire using Kocher forceps, arthroscopic basket forceps, needle drivers, and Kerrison rongeurs (see Figure 1). Additional fluoroscopic images of the distal femur were subsequently obtained, revealing the guidewire to be inadvertently impacted into the subchondral bone of the distal femoral condyle (see Figure 2). Due to the inability to retrieve the guidewire using other extraction methods, a decision was made by the surgeons to remove the guidewire antegrade through the distal femoral condyle.

Figure 1: Attempted retrieval of threaded guidewire with pituitary rongeur.

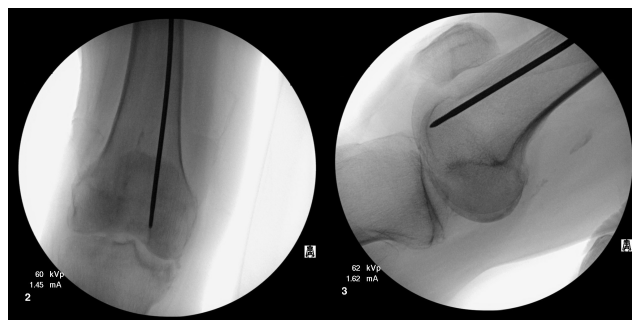
In this paper, the authors report on a case of inadvertent migration of the initial 3.2 mm. distally threaded guidewire into the femoral intramedullary canal after use of the cannulated opening reamer. The guidewire became inadvertently impacted into the subchondral bone of the patient's distal femur and was resistant to initial retrograde extraction techniques. Specific technical challenges presented

Figure 2: AP and lateral views of the right knee demonstrating distal subchondral impaction of the threaded guidewire.

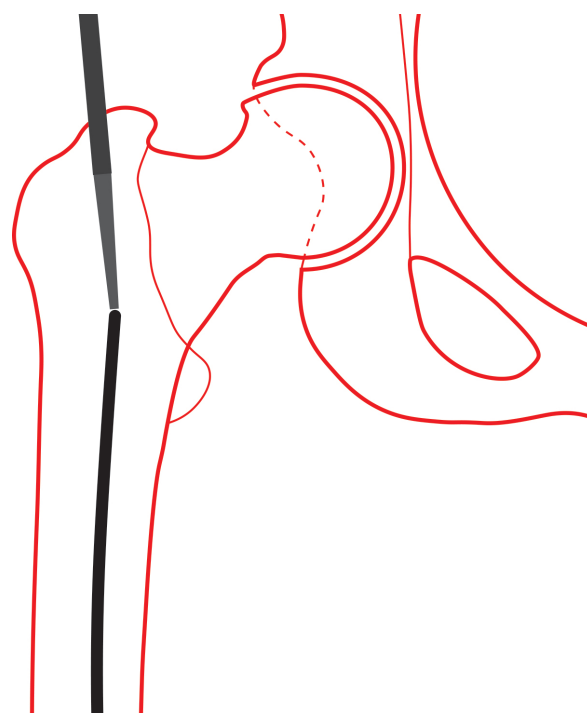
Figure 3: Schematic illustration demonstrating bone tamp placement into the opening of the proximal femur and in direct contact with the guidewire.

Traction on the operative leg was first released. The knee was then flexed to approximately 30° and held in the flexed position by a surgical assistant. A bone tamp was placed into the opening of the proximal femur and placed in direct contact with the guidewire (see Figure 3). A mallet was then used to gently tap the guidewire through the anterior aspect of the medial femoral condyle. The guidewire was advanced until tenting of the skin over the anterior knee was noted. A stab incision was made over the tip of the guidewire, and it was gently advanced further. Once enough guidewire was exposed, it was subsequently removed with a power drill.

The specific technical issues presented in this case included the inability to provide a firm grip of the guidewire, with the surgeons aiming to perform a lesser invasive method of extraction designed to conserve the patient's bone stock. The method described by the authors in this paper involved use of a bone tamp and mallet to gently tap the guidewire through the distal femoral condyles.

Strategic positioning of the leg is critical in order to remove the guidewire through the femoral condyles. With traction on the foot released, the knee could be manipulated and flexed to approximately 30 degrees. This method provided an adequate exit angle for guidewire through the distal femoral condyles and can be performed with the use of standard operating room tools.
