Case Report

Removal of Misplaced Left Ventricular Single Lead Pacemaker in a Patient Presenting with Recurrent Transient Ischemic Attacks

Spartan Medical Research Journal

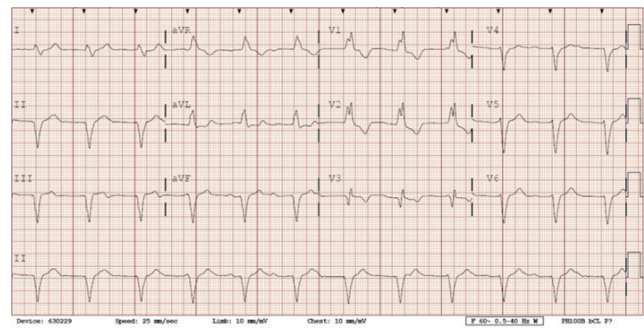
Figure 1

12-lead Electrocardiogram Consistent with Right Bundle Branch Block (RBBB)

Both ECG and chest x-rays can provide clues for potential misplacement of ventricular pacemakers. Proper placement in the apex of the right ventricle will demonstrate a left bundle branch morphology (LBBB) on ECG. A right bundle branch block (RBBB) pattern should raise suspicion for left ventricular stimulation due to lead malposition. Although uncommon, a RBBB can result if the pacing electrode enters the coronary sinus and into posterior interventricular vein, inserts into the interventricular septum, or with normal pacing in a dilated right ventricle.^{5-7,10} Notably, 8 to 13% of patients will still have a RBBB morphology on ECG with normal right ventricular pacing.⁹ While a post procedure ECG should be performed for confirmation of proper lead placement of every CEID, this test cannot entirely confirm lead placement.

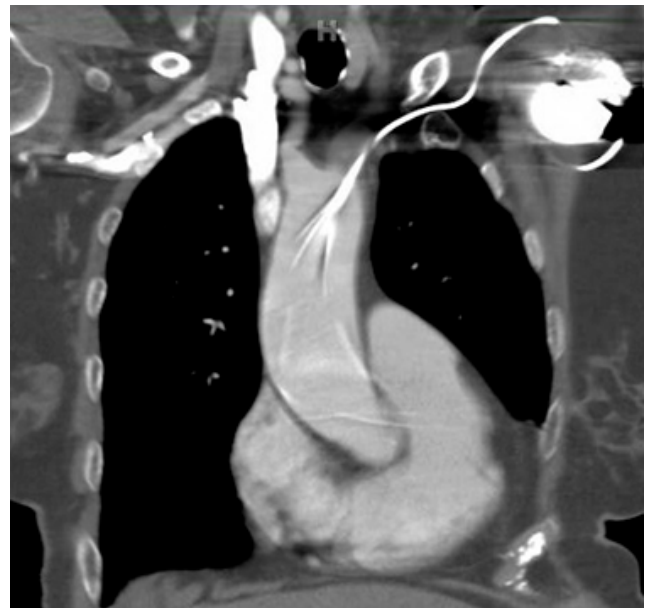
Figure 2

with an episode of left-sided weakness, slurred speech, and the patient was diagnosed with a transient ischemic attack (TIA). Cardiology and neurology consults were obtained. She had been receiving warfarin for her atrial fibrillation and her international normalized ration (INR) on admission was at a therapeutic level. The authors could not exclude transient subtherapeutic INR levels leading to clot formation and thromboembolic phenomenon from her atrial fibrillation. However, her electrocardiogram (ECG) demonstrated an abnormal finding that provided an important clue for the etiology of her presenting symptoms. Her ECG demonstrated a ventricular paced rhythm with a right bundle branch block pattern (Figure 1). A chest x-ray was performed that demonstrated misplacement of the single lead pacemaker with an atypical posterior curvature path. A computerized tomography (CT) scan was performed which further demonstrated her misplaced single-lead pacemaker traversing the aortic valve into the LV (Figure 2).

CT Chest Demonstrating Misplaced Single Lead Pacemaker

Due to her recurrent TIAs from the misplaced lead, the authors decided to pursue surgical retrieval. She underwent pre-operative catheterization to assess any burden of coronary artery disease and a peri-operative trans-esophageal echocardiogram. The patient subsequently had an extraction of her LV pacemaker wire via aortotomy and implantation of an epicardial pacemaker. To date, the patient has been doing well without any further sequelae.
